Accelerated Freshwater Harbor Corrosion Study In The Duluth-Superior Harbor

Gene Clark, P.E.¹, Dave Bowman, P.E.², Jim Sharrow, P.E.³, Chad Scott, P.E.⁴
and Jeff Gunderson⁵

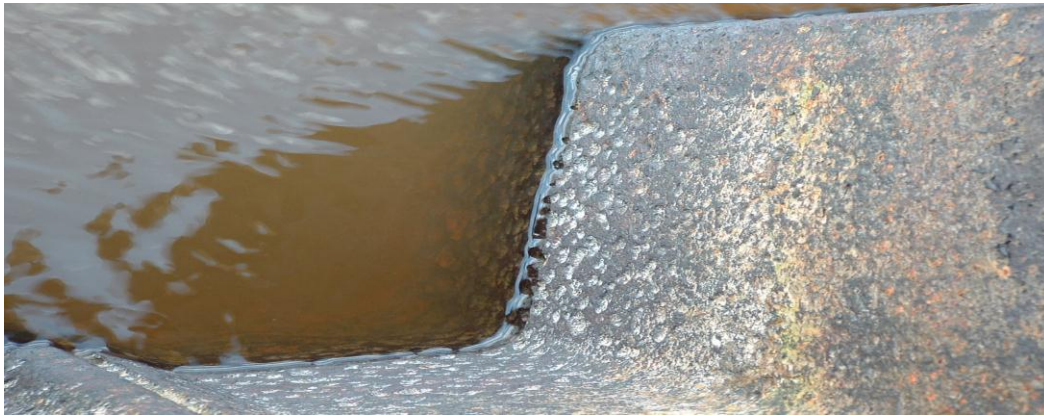
Photo 1. Bulkhead Pitting at Superior Entry

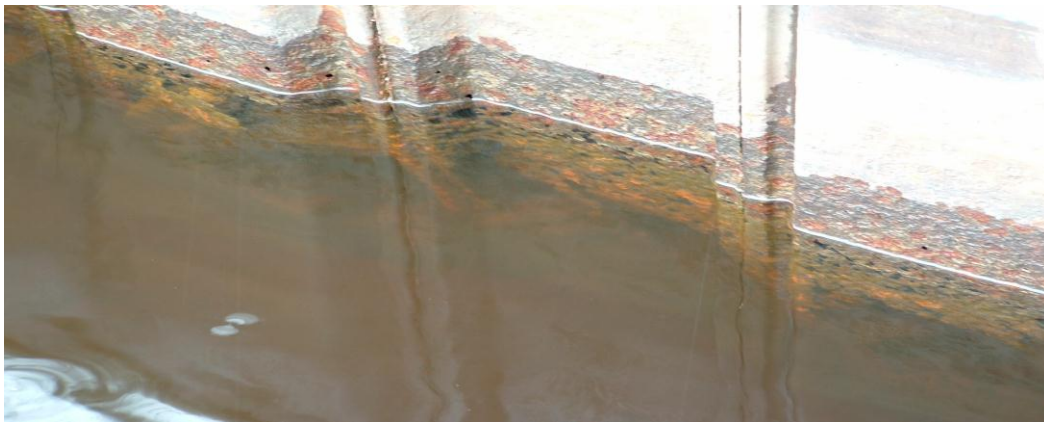
Photo 2. Sheet Pile Pitting and Large Perforations at Local Marina

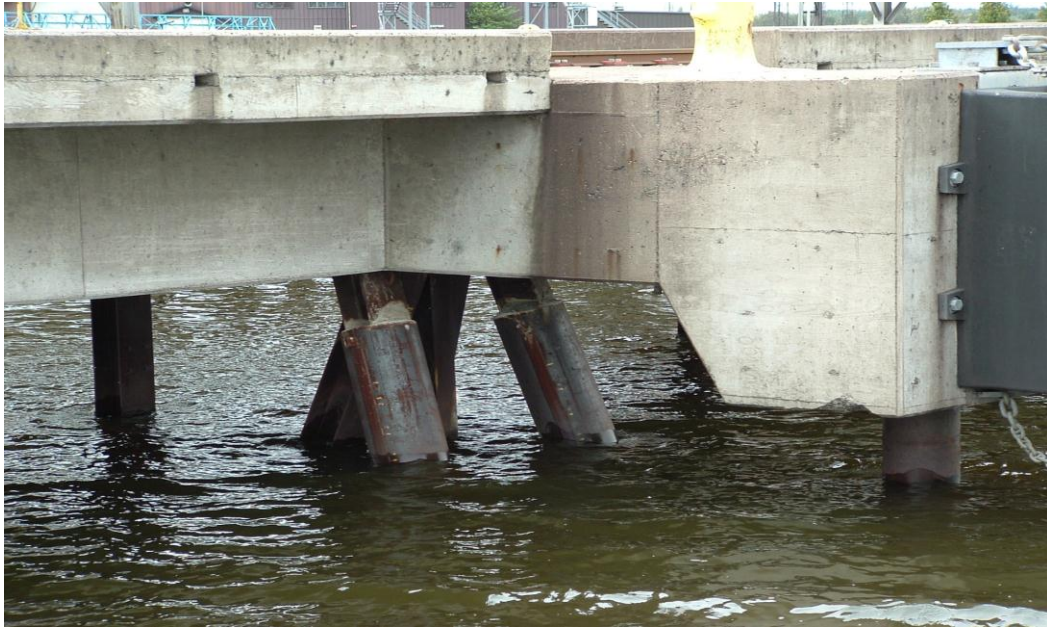
Photo 3. H-Pile Jacketing Repair

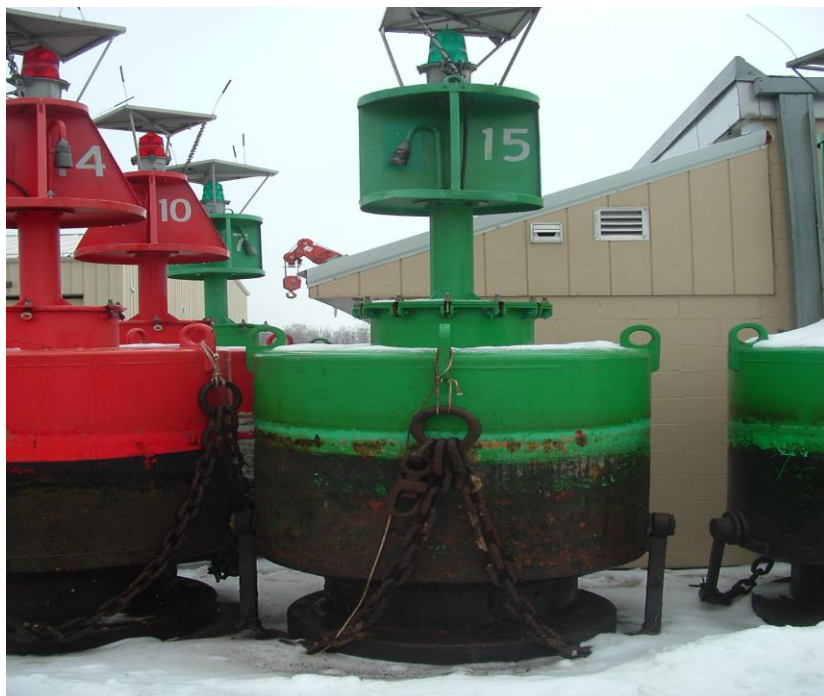
Photo 4. U.S. Coast Guard Channel Marker Buoy & Anchor Chain Bridle

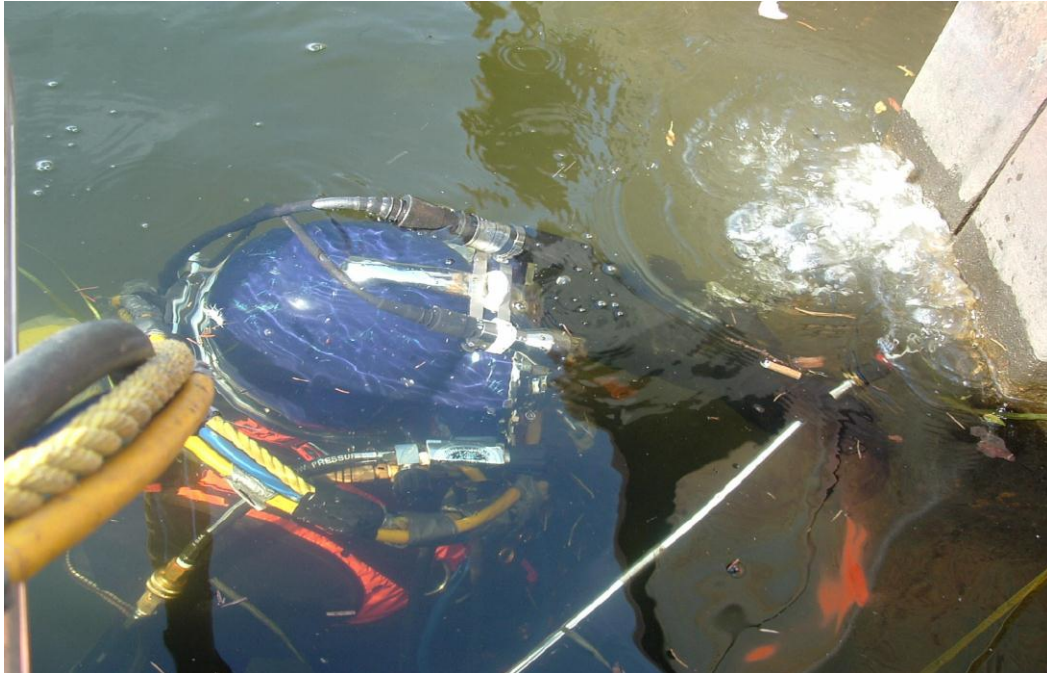
Existing Structure, Water Quality & Initial MIC Evaluations: Existing harbor structures are being catalogued by type, age, owner, depth, condition, etc. In addition, divers (see photo #5) have completed the underwater inspection of many facilities throughout the harbor. Additional parameters measured by the divers included thickness loss due to corrosion, analysis of water samples (PH, DO, conductivity, turbidity & temperature) at several water depths at each inspection station, light intensity near the structures, and water clarity. Corrosion product characterization was also completed noting pitting details, marine growth present, extent of corrosion, etc. The initial MIC study is also currently underway consisting of collecting corrosion product samples and analyzing them for the presence or absence of either iron-oxidizing or sulfate-reducing bacteria by DNA testing of the samples (see photo #6). The divers also conducted instantaneous corrosion rate (ICR) measurements at several locations. The ICR study consisted of structure in the corrosion zone, letting it equalize for a week and then taking the measurement of material loss.

Photo 5. Diver Preparing Sheet Pile Prior to Pit Inspection

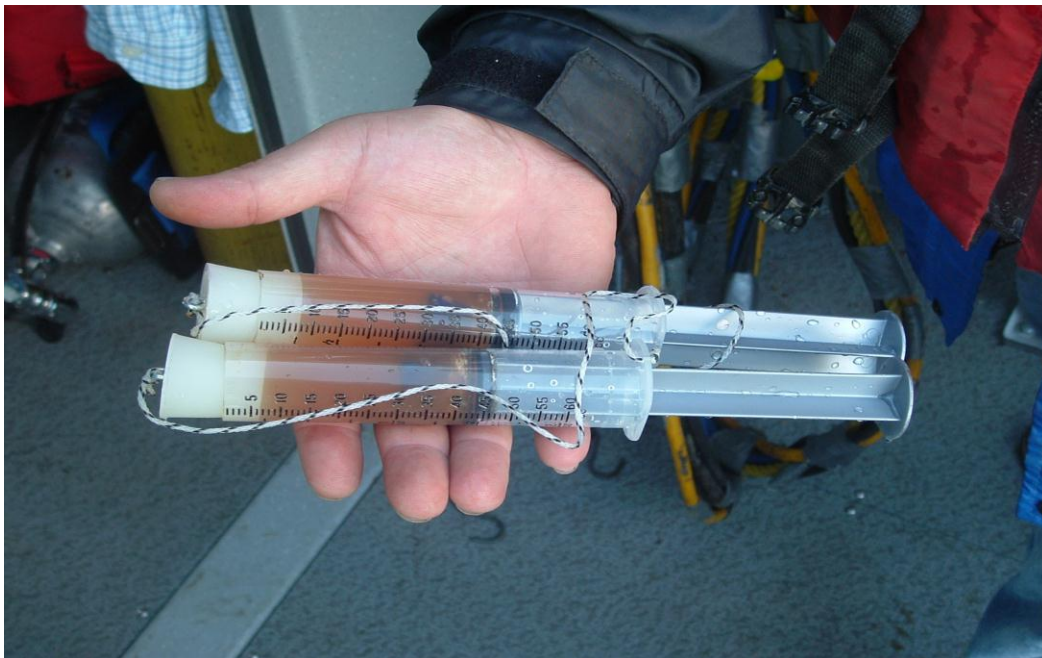
Photo 6. Corrosion Product Samples Collected for MIC Analysis
