# Mystery in Minnesota

*Duluth harbors unusual corrosion.*

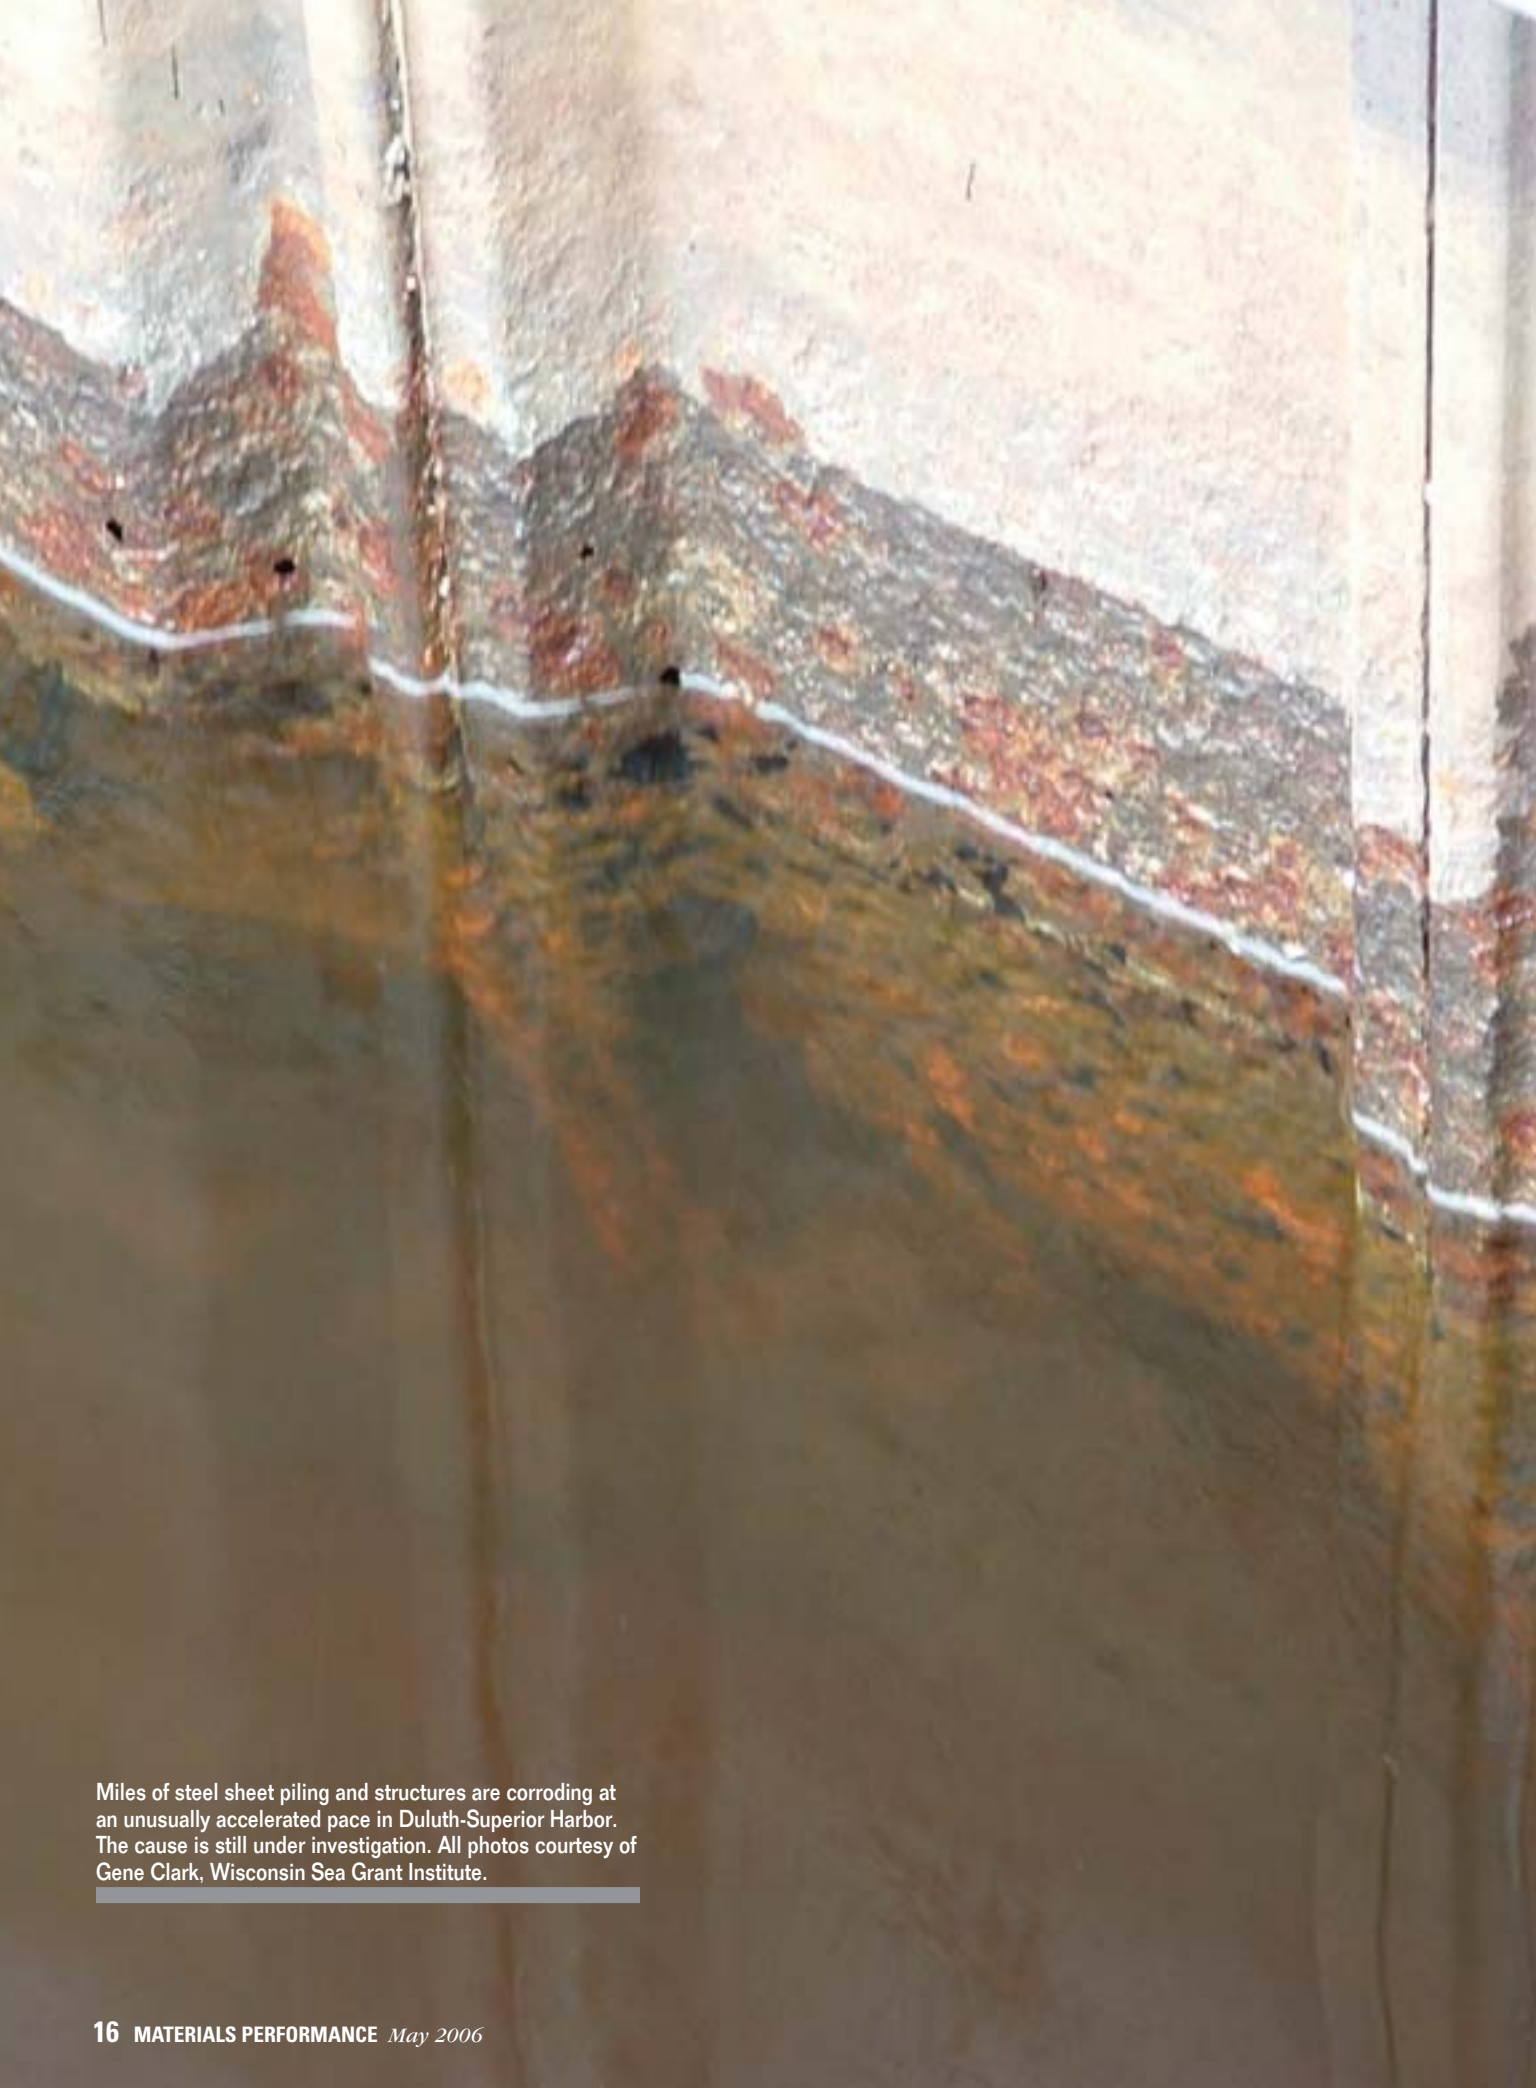
Miles of steel sheet piling and structures are corroding at an unusually accelerated pace in Duluth-Superior Harbor. The cause is still under investigation. All photos courtesy of Gene Clark, Wisconsin Sea Grant Institute.

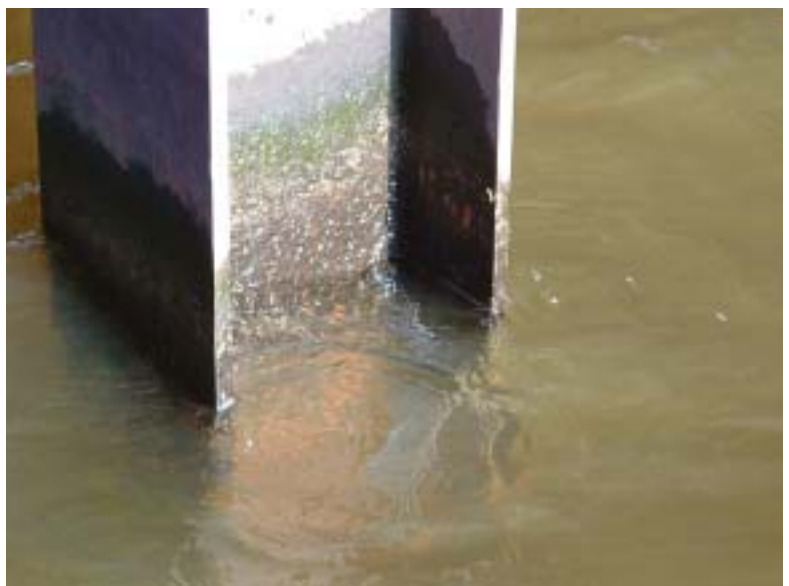
Comparisons of sheet piles of different ages within the harbor indicate that the increased rate of corrosion began in the late 1970s. Underwater inspections reveal that the corrosion is widespread, affecting all types of steel piling buttressing the docks. Most of the steel is riddled with small pits in diameters of 0.25 to 1 in. (6 to 25 mm), primarily in the first 4 to 6 ft (1.2 to 1.8 m) below the waterline, and tapering off around 10 ft (3 m). (Below 10 ft, there is very little corrosion, despite the colonies of zebra mussels that begin at that depth and range to the bottoms of the steel plates.) Some of the steel beams supporting the dock structures have holes the size of footballs (these are being repaired). The pits of corrosion are described as having an orange coating that generally covers the pits.

Most of the corroding steel sheet pilings and beams—which may require up to \$100 million to repair—are riddled with pits.

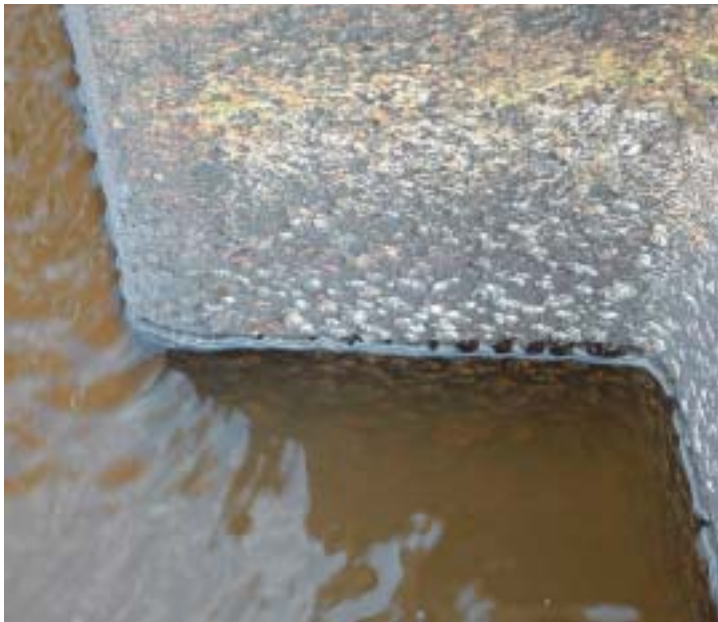
Researchers examined 12 possible causes of the accelerated corrosion; the exact cause still remains a mystery.
